Manhole Inspection Summary

Manhole # S06II2017MH

Insp Date: **8/7/06 7:38 AM**

Location Address: **3305 SEVEN MILE LN**

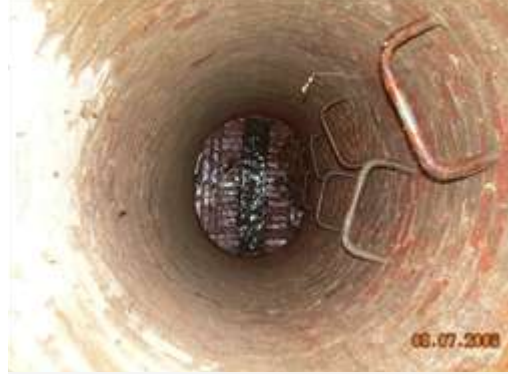
Top View

Adjustment, Corbel and Barrel infiltration. Corroded steps. Evidence of surcharge - Bench debris.

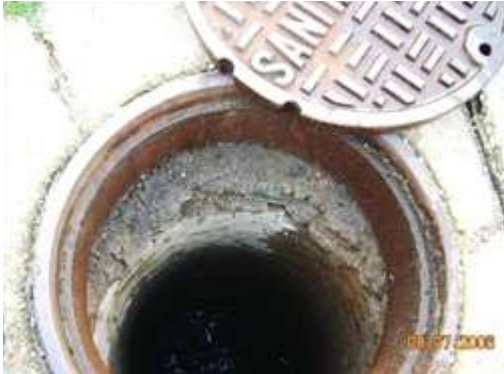
Defect

Frame leaks. Frame offset. Adjustment deterioration, loose brick and infiltration.

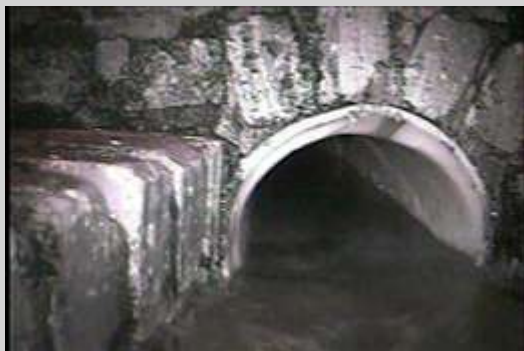
8 in. Circular Gravity Sewer Pipe In @ 6 O'Clock

Bench deterioration.
